CALTHORPES' HOUSE

CONSERVATION AND MANAGEMENT PLAN

FINAL
ISSUE 3
09G0
30 July 2010

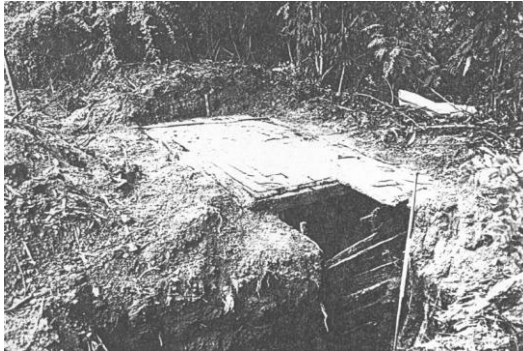
Figure 28: Partly uncovered shelter during repairs. Northern roof and northwestern wall are exposed showing the shaft.

Inspection of the shelter in 1990 revealed that it was in surprisingly good condition

"The extent of good surviving material was remarkable. The end walls, fascia, parapet and spreaders were discarded and the shaft lining was missing but the greater part of the fabric needed only localised repair. Conoforia had attacked the ends of the joists, some boards and the bases of the studs where the timber was damaged by fire or by tunnelling rodents. A young colony of termites caused considerable damage between the shaft ... but this area was affected by the fire. The roof decking was completely sound except where the malthoid had been penetrated by rabbits. There was no sign of wet rot or of excessive dampness."²²

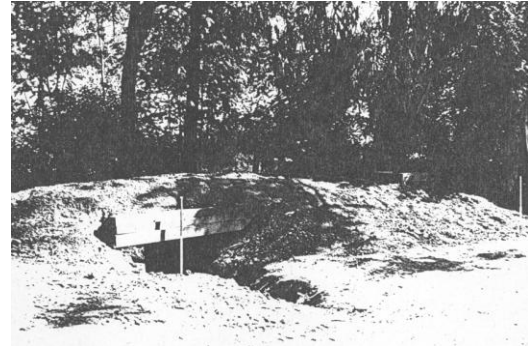
Figure 29: The Restored Air Raid Shelter (photo facing Northwest 1 May 1990)

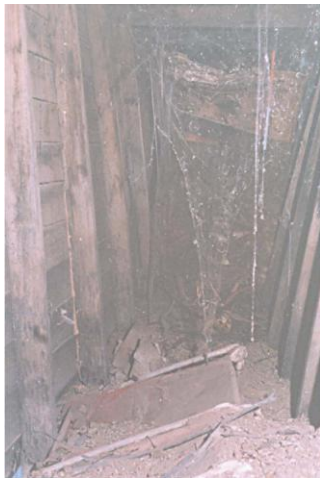
Figure 30: Interior as found, facing north (26 March 1990)

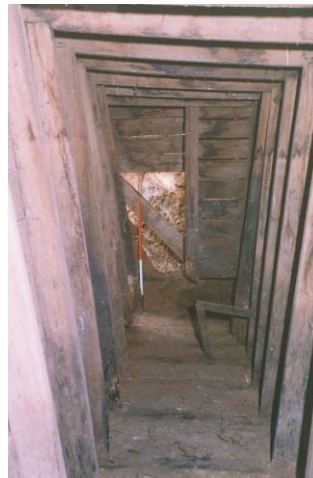
31: Interior after removal of detritus, facing south (29 April 1990)

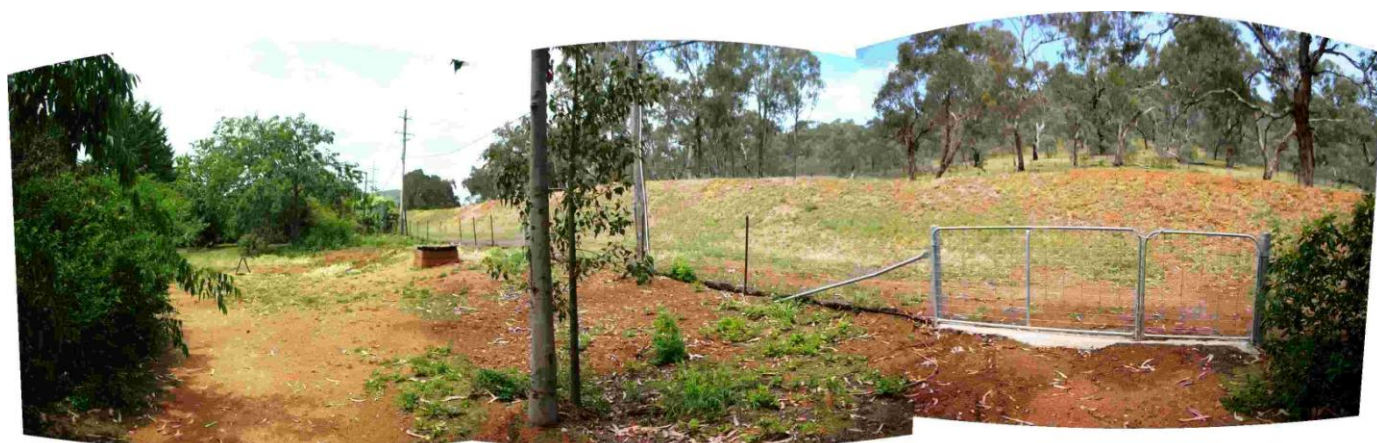
Figure 33: Rear of site showing recent installation of gate and fencing, the air raid shelter's emergency exit/ventilator and indigenous vegetation on Red Hill.

Note: the fence was rebuilt with rabbit-proofing and some original components in 2009

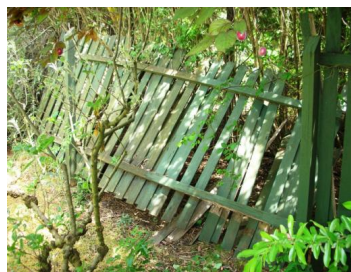
Figure 43: One of the 1980s lapped fences (N/W) in need of repair.

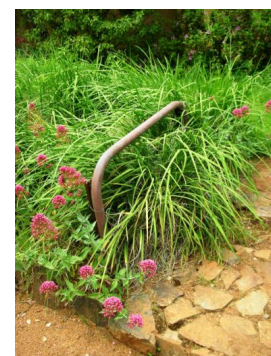
Figure 47: Existing intrusive handrail needs to be replaced.

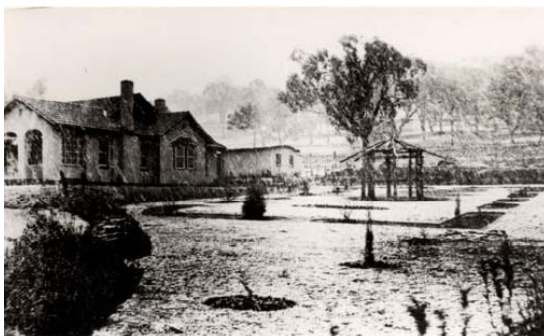
Figure 105: c 1927 – the formal side garden – a rectangular lawn surrounded by neat beds of shrubs or trees, with central rustic arbour.

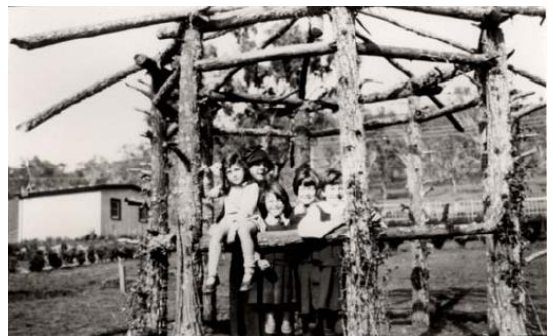
Figure 106: Spring 1928 – detail of arbour, new hedges and paling fence.

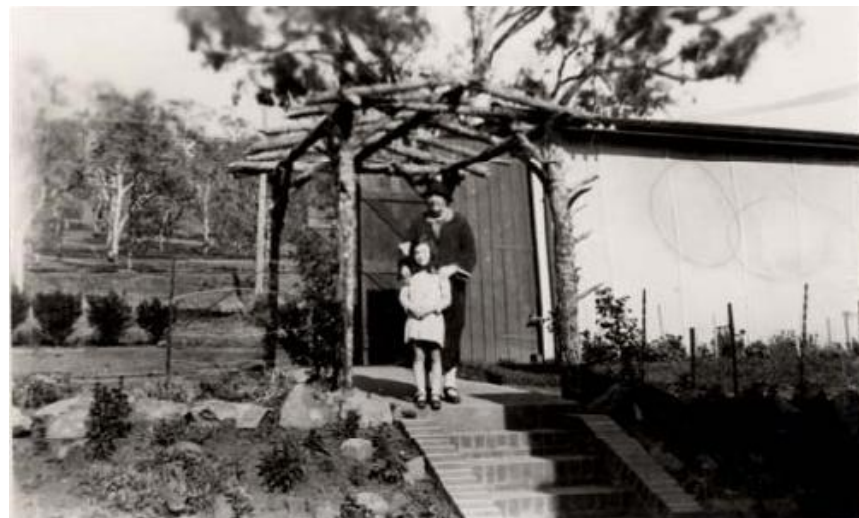
Figure 109: Spring 1928 – steps up to garage, rustic pergola apparently with young banksia roses on either side. This was planted as a dense shrubbery especially on right to screen garage.

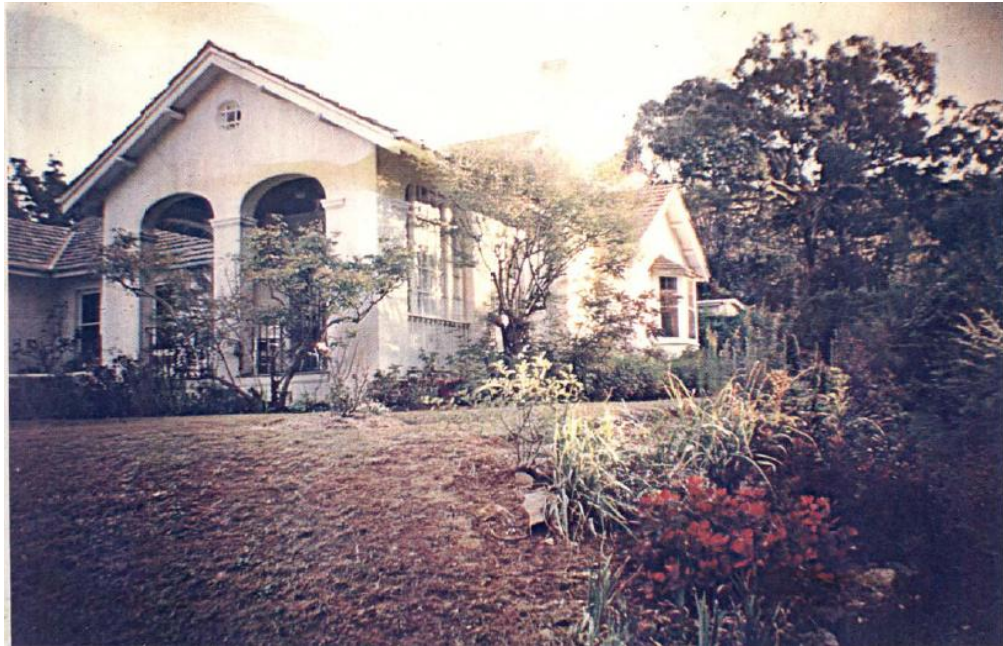
Figure 119: View from the northern arm of the front drive showing the 'house platform' garden lawn and rockery, 1984. The large eucalypt at the rear is behind the garage and has not grown appreciably since 1927 (refer earlier photographs).

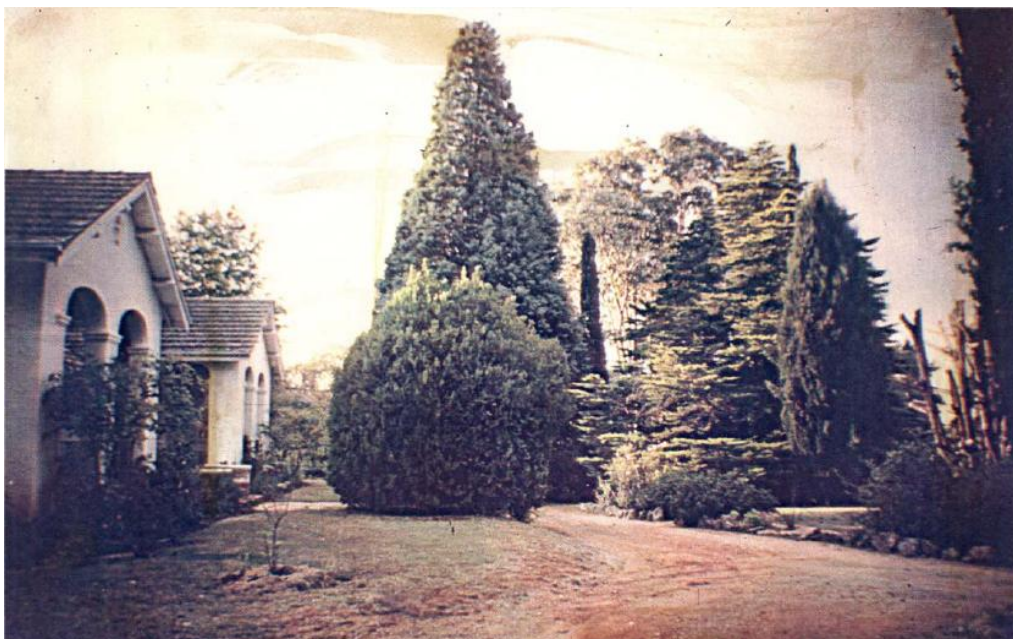
Figure 120: View from the south drive across the front of the house, showing the low side of the 'house platform' garden, the roses around the front drive (on the right) and the large cypresses in the side garden, 1984.

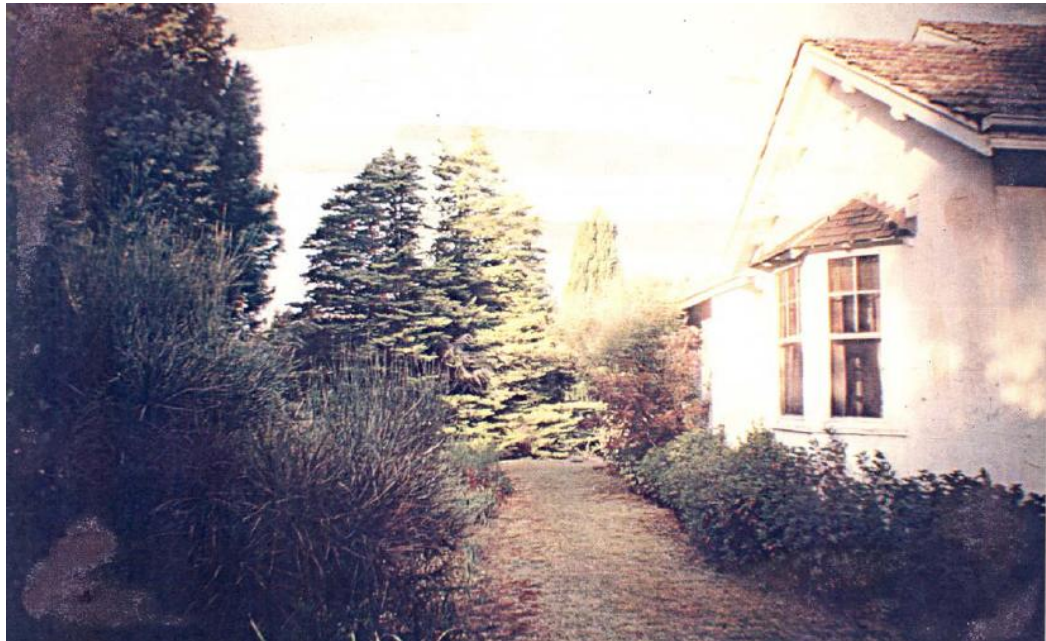
Figure 121: Looking along the north side of the 'house platform' garden towards Mugga Way, 1984. Note how the geraniums have taken over the edge of the house, the overgrown broom of the side garden (on the left) and the scale of the cypress trees toward Mugga Way.

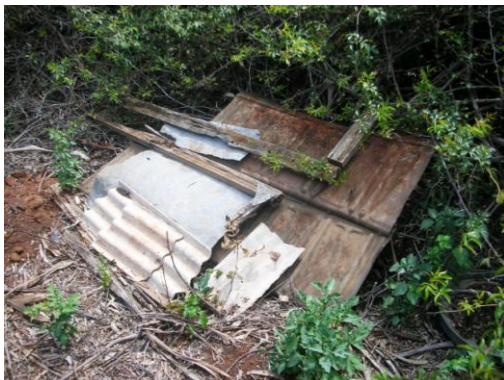
V16: One of the 1980's lapped fences (N/W) in need of repair.
