**PROCEEDINGS
HIGH ALTITUDE REVEGETATION
WORKSHOP NO. 18
MARCH 2008**

COLORADO WATER RESOURCES RESEARCH INSTITUTE
Information Series No. 107
Joe E. Brummer, Editor
March, 2008

**Colorado State University
Fort Collins, Colorado
March 4-6, 2008**

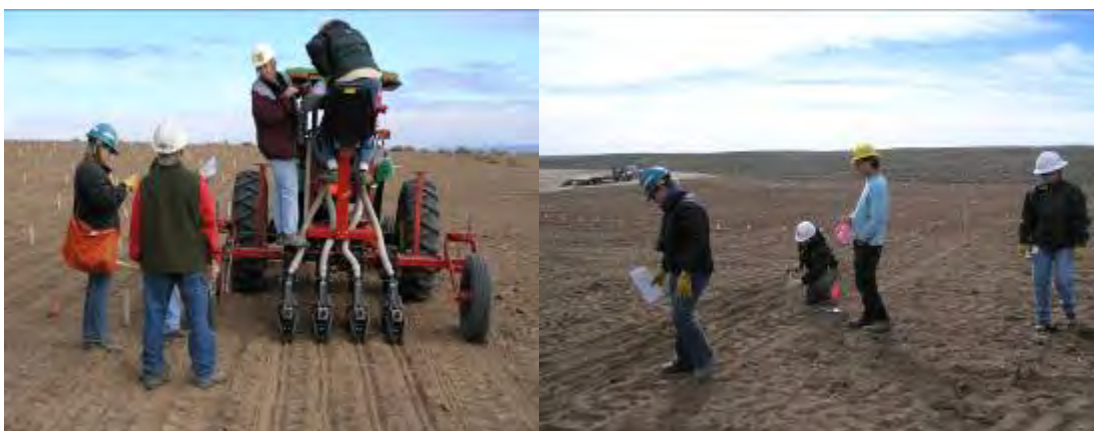
Shell replicated plots, October 2005

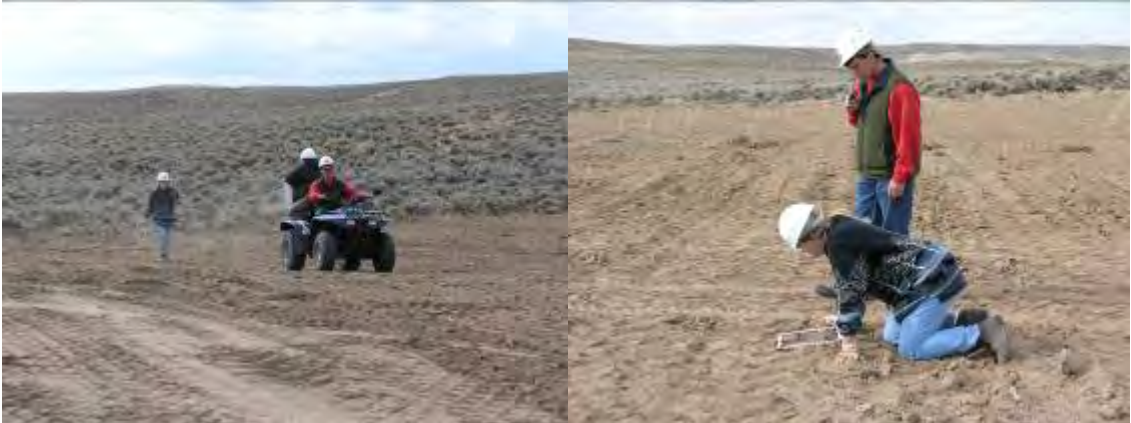
Shell broadcast-seeded plots, October 2005.

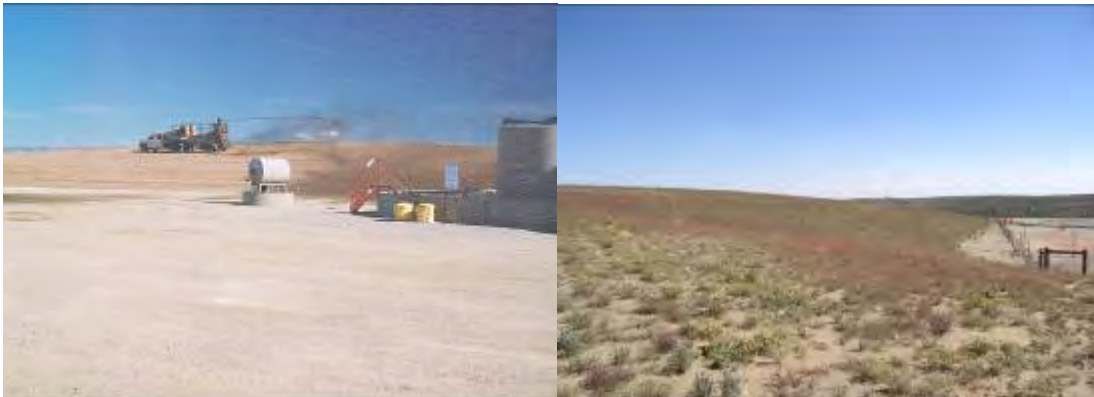
Shell hydro-seeding with Shell seed mixture: December 2005 (left) and October 2007 (right).

The hydro-seeding method was the least successful, and in fact, was twice considered a failure. Mixing seed directly into the slurry and applying as a one-step mulch application on a smooth slope surface, promotes seed movement and seedling desiccation due to drying and shrinking of the mulch. To restrict seed movement and promote seed-to-soil contact, a two-step approach is preferred where 1) the seed is separately mixed in a trace amount of mulch and applied directly to a roughened soil surface, followed by 2) a second application of mulch to reduce soil erosion and enhance micro-climate conditions necessary for germination and establishment (Holzworth, 2007).

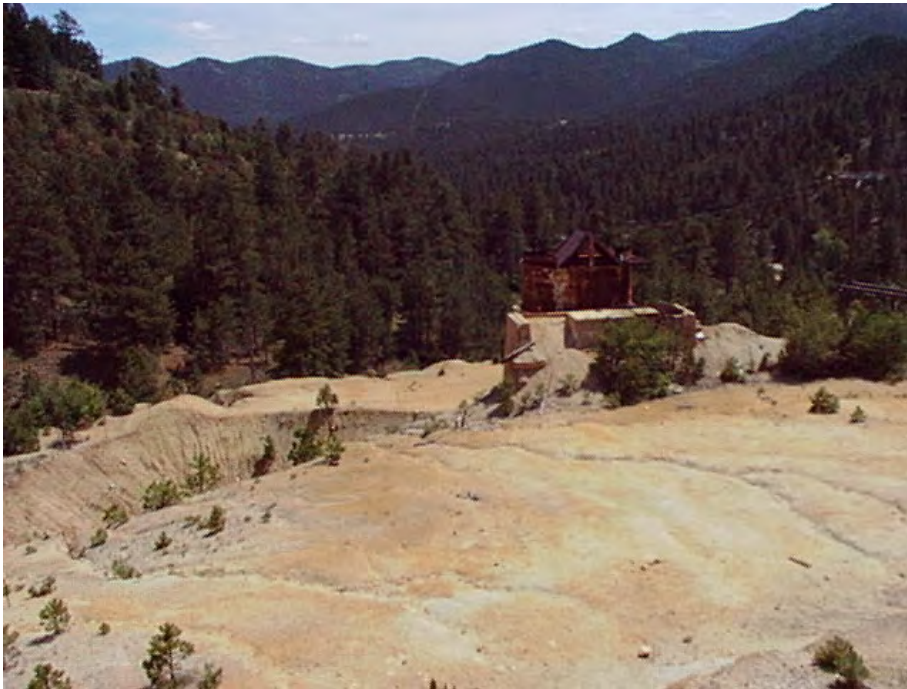
Photo 2. Ore bin and loading structure amidst waste unvegetated waste rock pile.

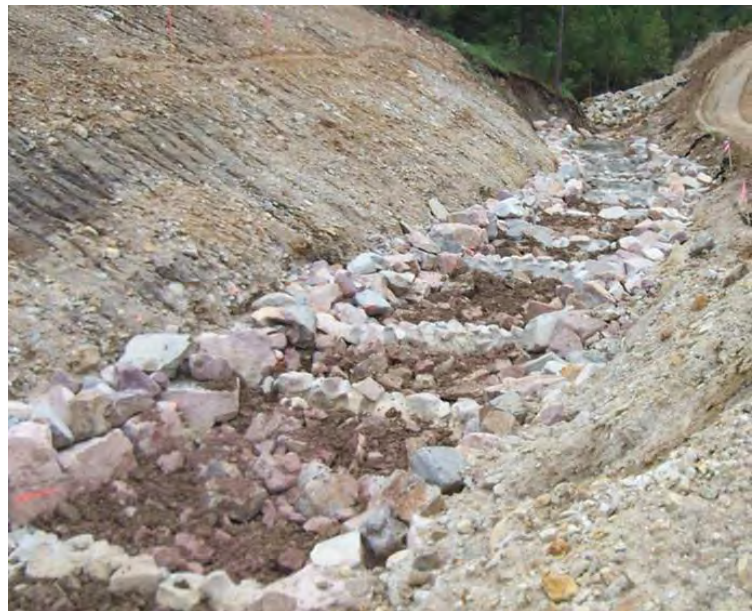
Photo 8. Balarat Gulch Diversion Channel, 2004.

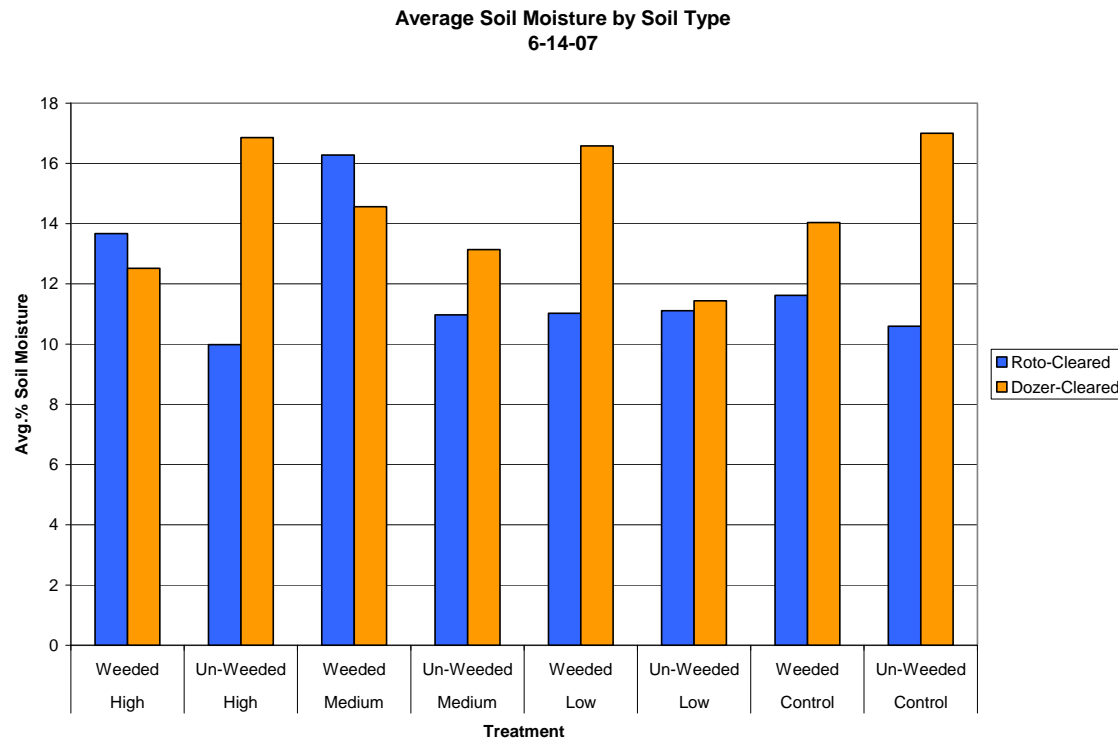
Figure 5. Average soil moisture by soil type and weeding treatment, June 14, 2007.

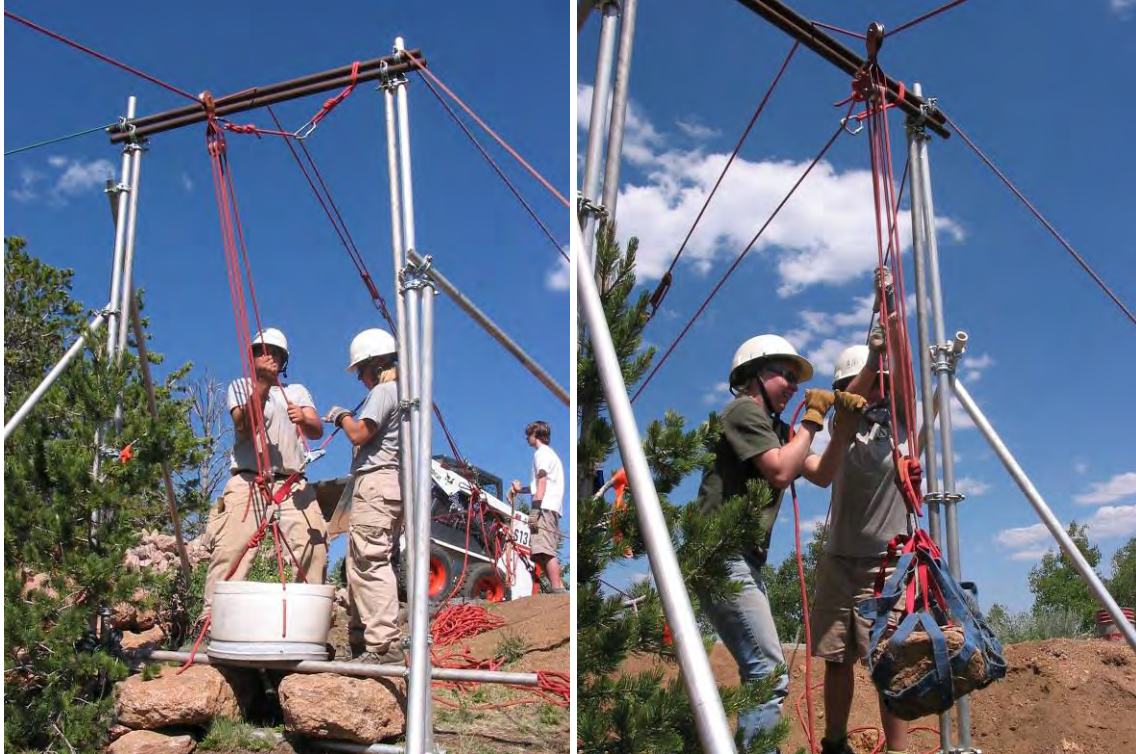
Figure 1 and 2. Example of Rock Tram with bucket and rock sling

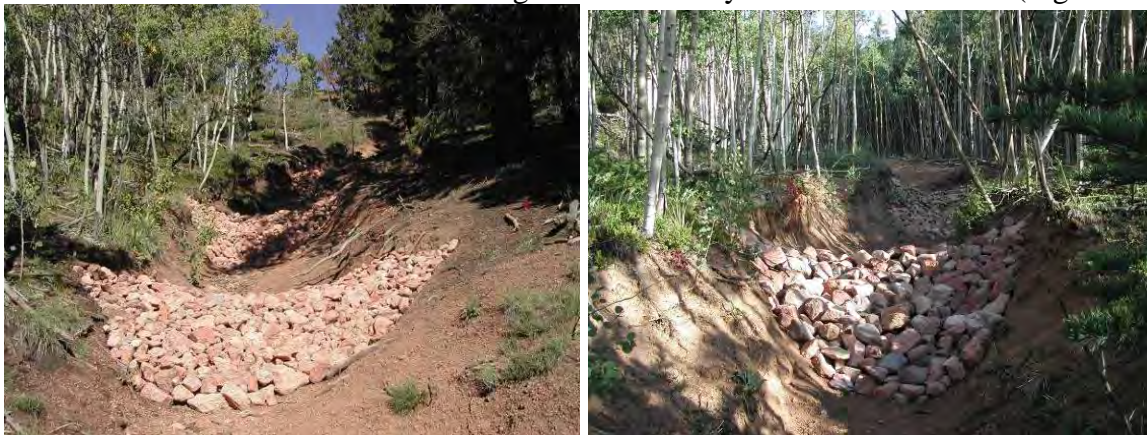
Figure 7 and 8. Examples of finished check dams.

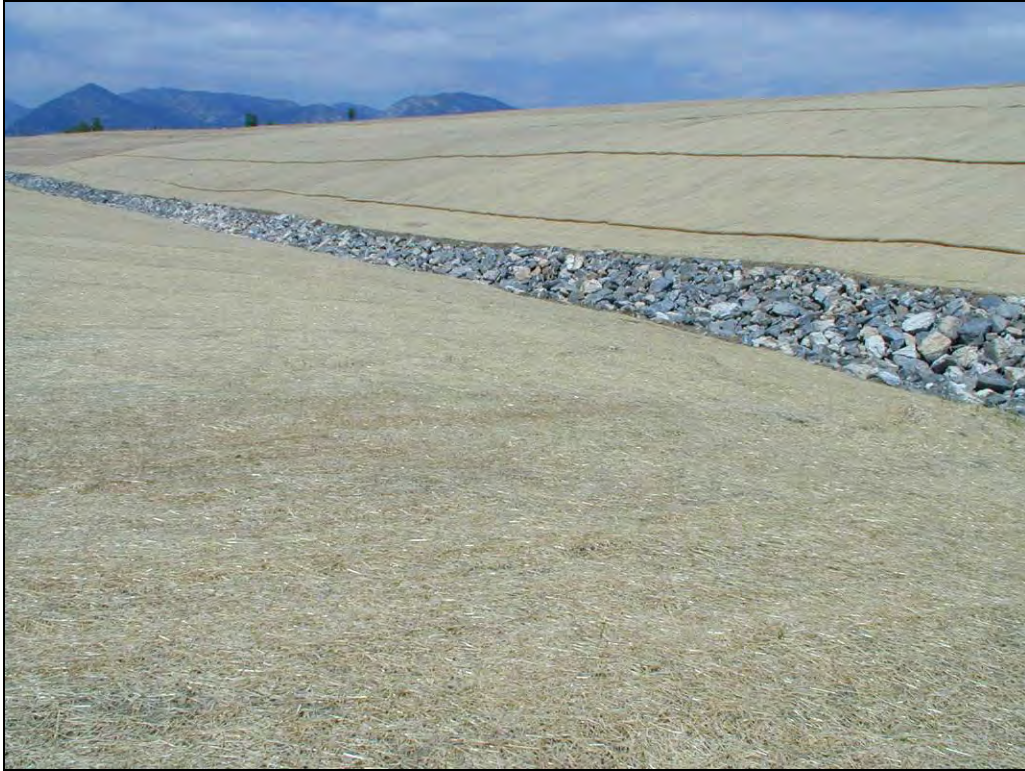
Figure 3. Temporary erosion blankets (and wattles on far hillside) used to protect soil and prevent erosion on the hillslopes at the Site.

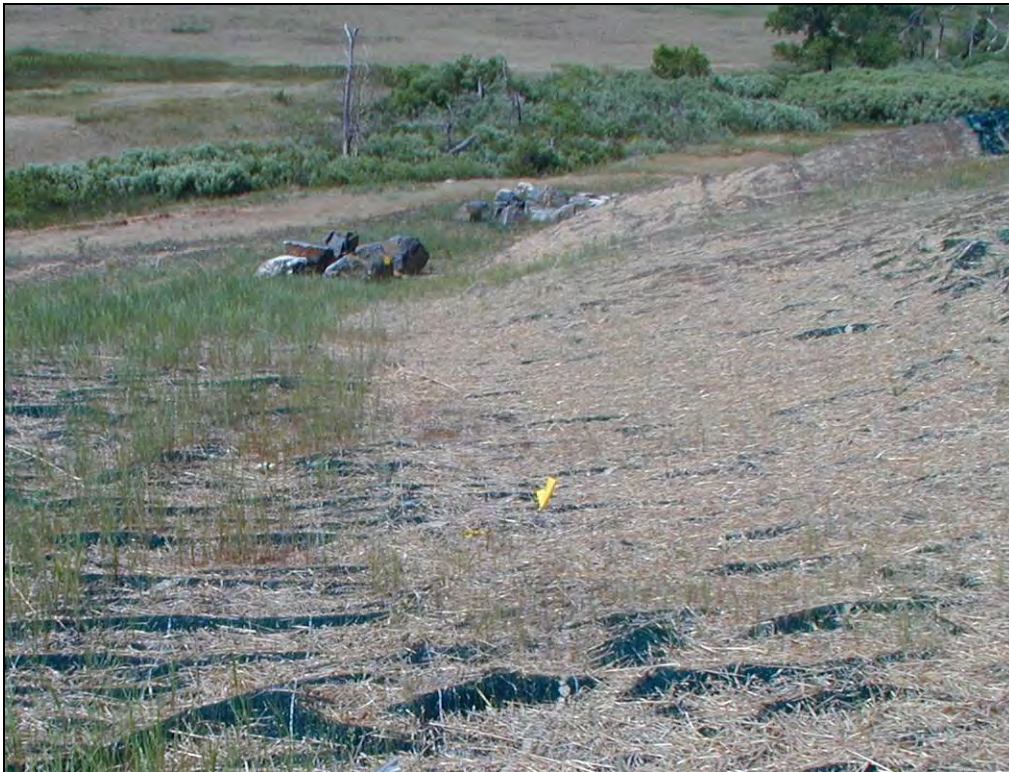
Figure 5. Windblown straw deposited in a drainage inhibiting plant germination.

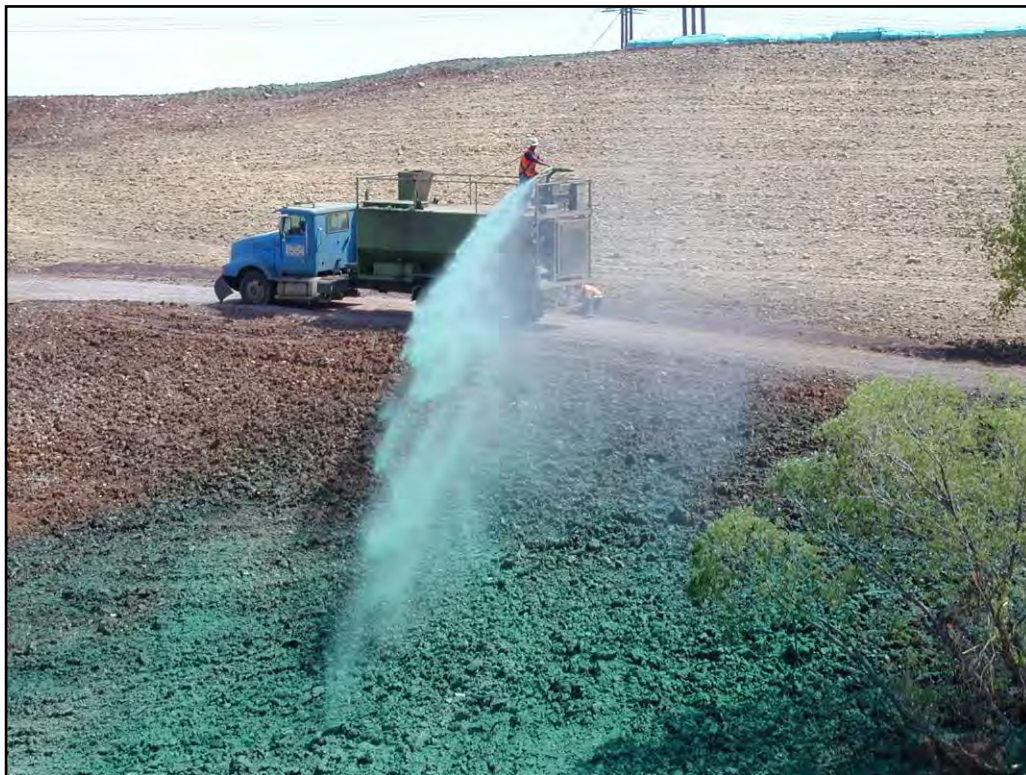
Figure 6. Flexterra application on a hillslope at the Site.

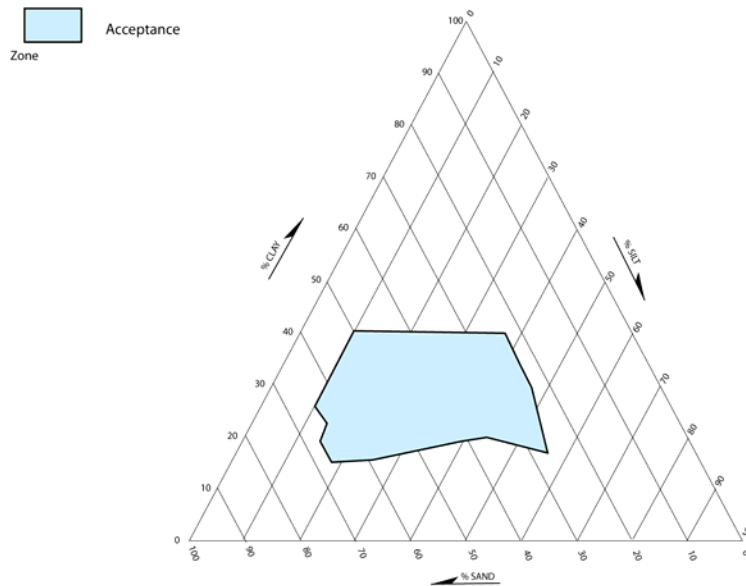
Figure 4. Borrow Soil Texture Acceptable Zone
Other Agronomic Considerations for Acceptable Borrow Soil

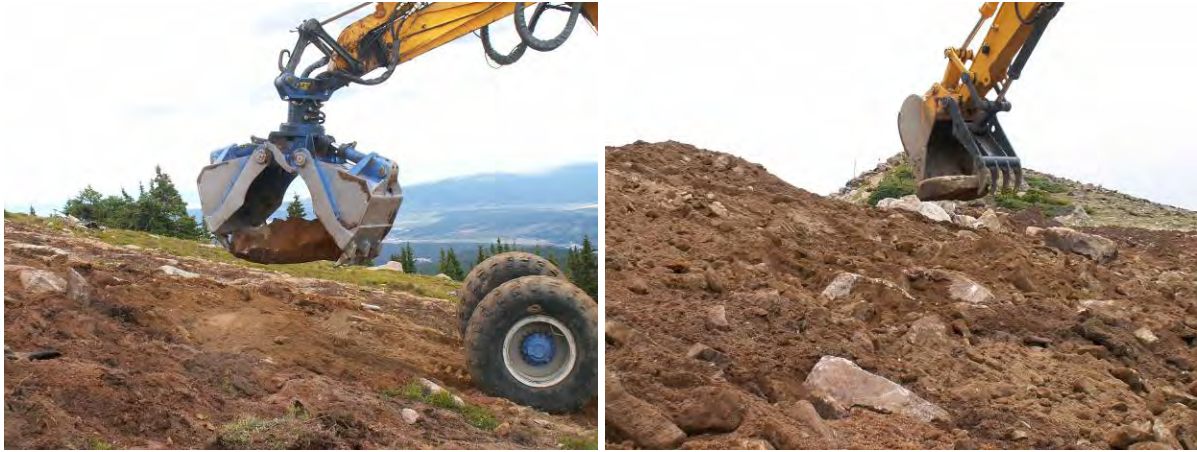
Photo: Eagle Wind rock placement with clam bucket and spider hoe. (Right) Panoramic lift rock placement with excavator with a bucket thumb

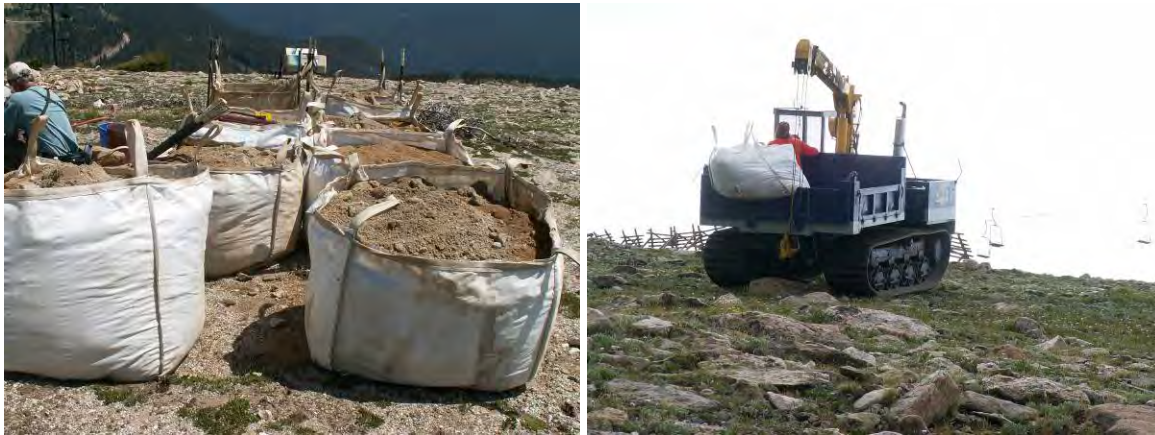
Photo: Soil bags used above treeline. Limited loose soil on undisturbed ground. (Right) One soil bag was removed by Maruka rubber tracked dump truck the others were removed by helicopter

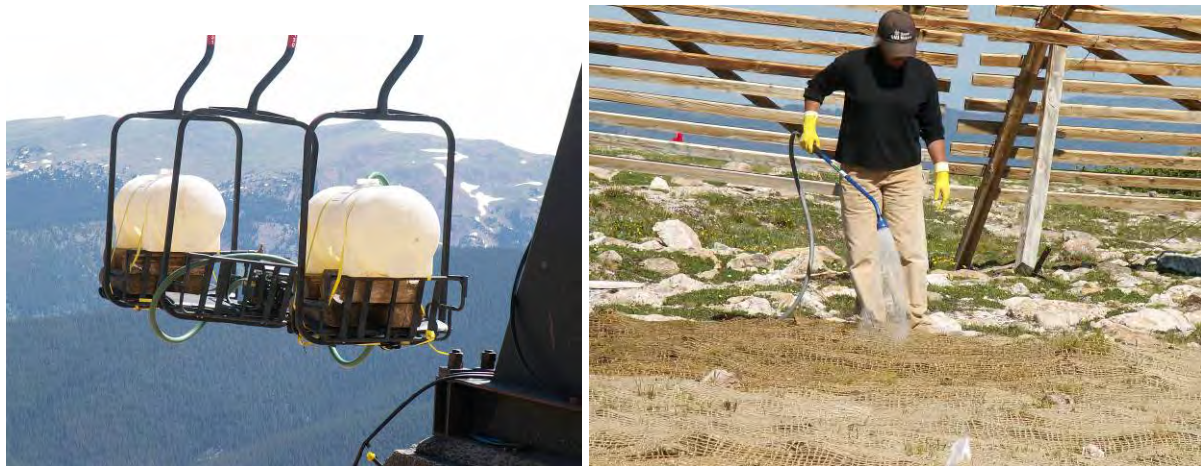
Photo: Water tanks and pump on the Panoramic lift. (Right) Soaking watering spray

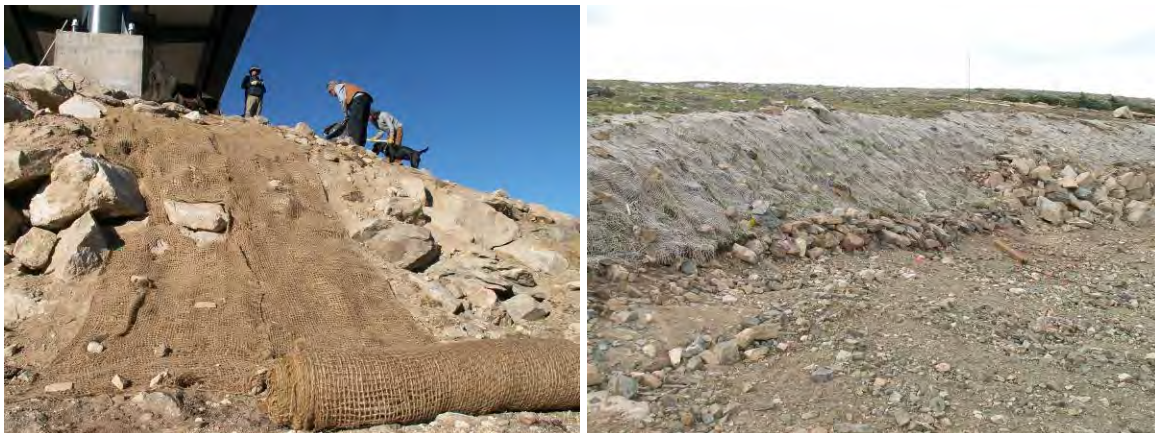
Photo: Jute mat installation Panoramic lift. (Right) Jute mat installation Eagle Wind lift
